Snow Pit Profile  
**North of Dwaynes**  
**Bridger, MT**  
Elevation (ft) **8567**  
Aspect: **77**  
Specifics:

Observer: **Doug Chabot**  
**Sun Nov 28 11:00:00 MST 2010**  
Co-ord: **45.82694 N 110.93189 W**  
Slope: **25**  
Wind loading: **previous**

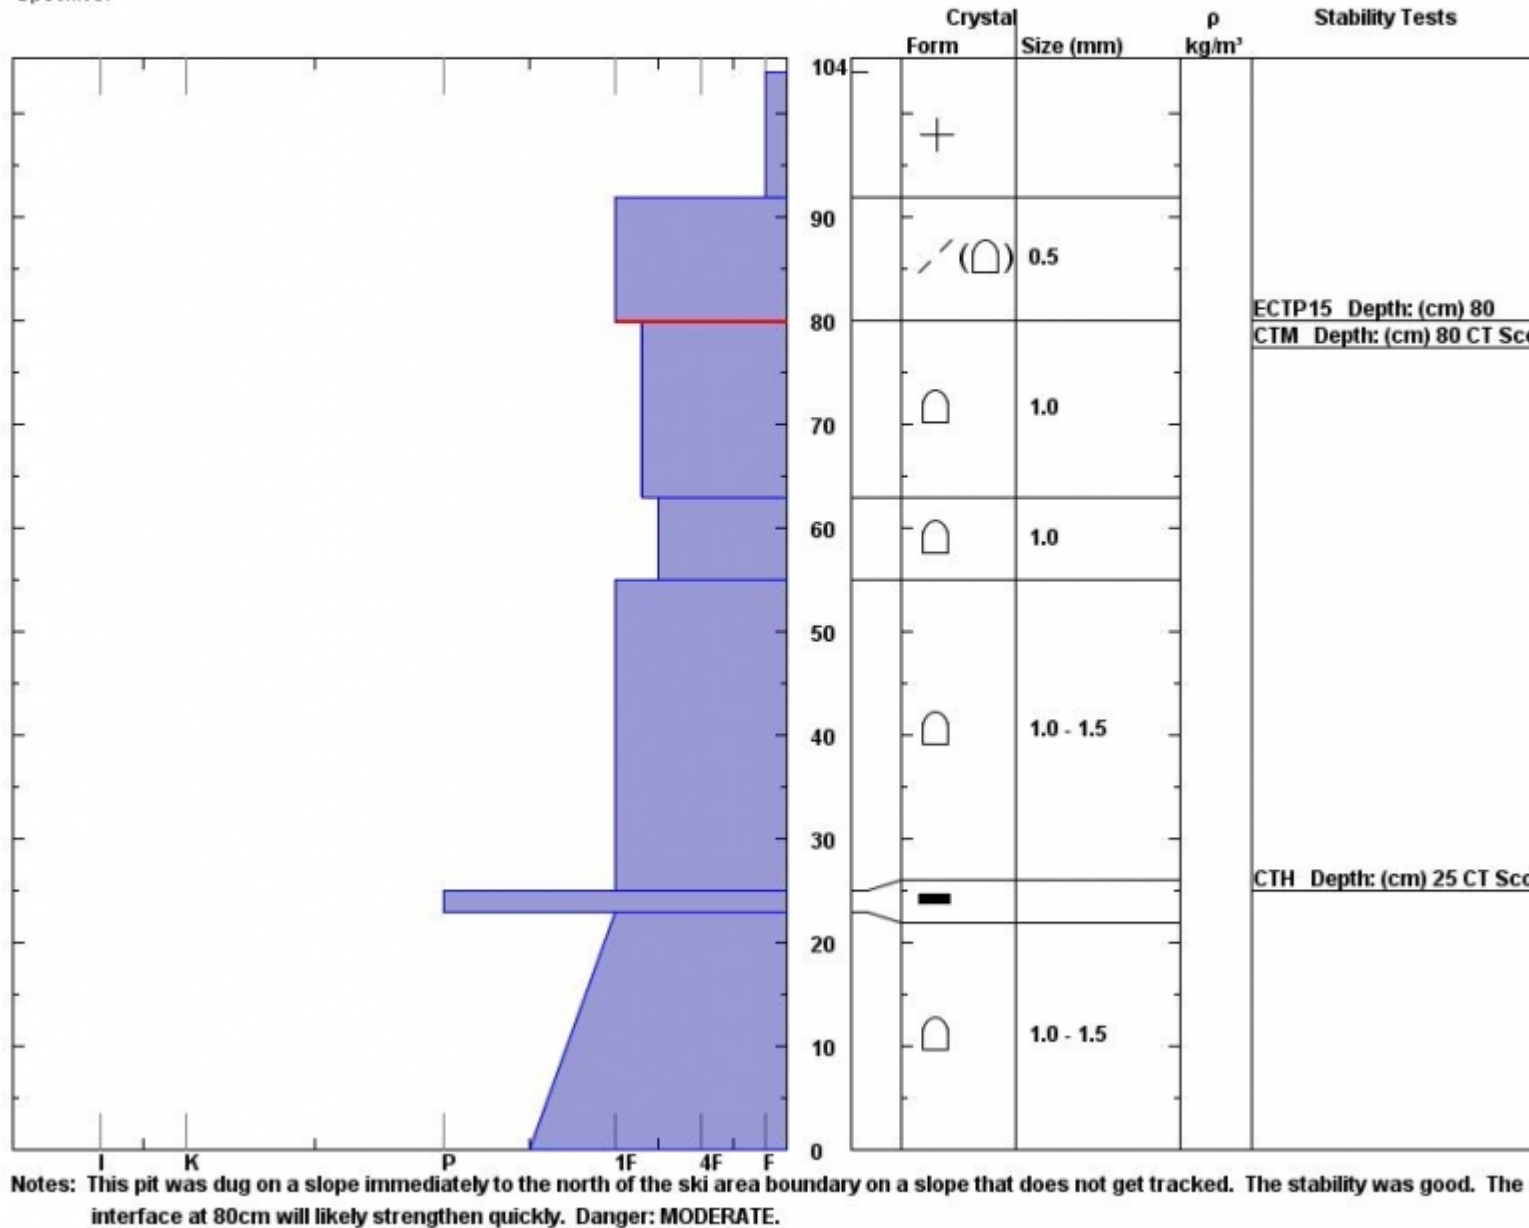
Stability Test Notes:  
**80: Q2**  
**80: Q2**  
**25: Q3**

Layer notes:  
**63-80: Pro**  
**23-25: dec**

This snowpit was dug off the ridge top as soon as we exited the ski area boundary. It's on a small representative east-facing slope that does not get skied. The pit was showed good stability. Our only concern was the interface at 80 cm where a wind slab is sitting on an older surface. There's no persistent weak layer (facets) so I think it will heal/bond quickly, but this interface fractured and propagated in with a score of ECTP11, Q2. Photo: GNFAC
