Advisory Region Bridger Range

Forecast link: <u>GNFAC Avalanche Forecast for Sat Nov 18, 2017</u> Bridger Range, 2017-11-16

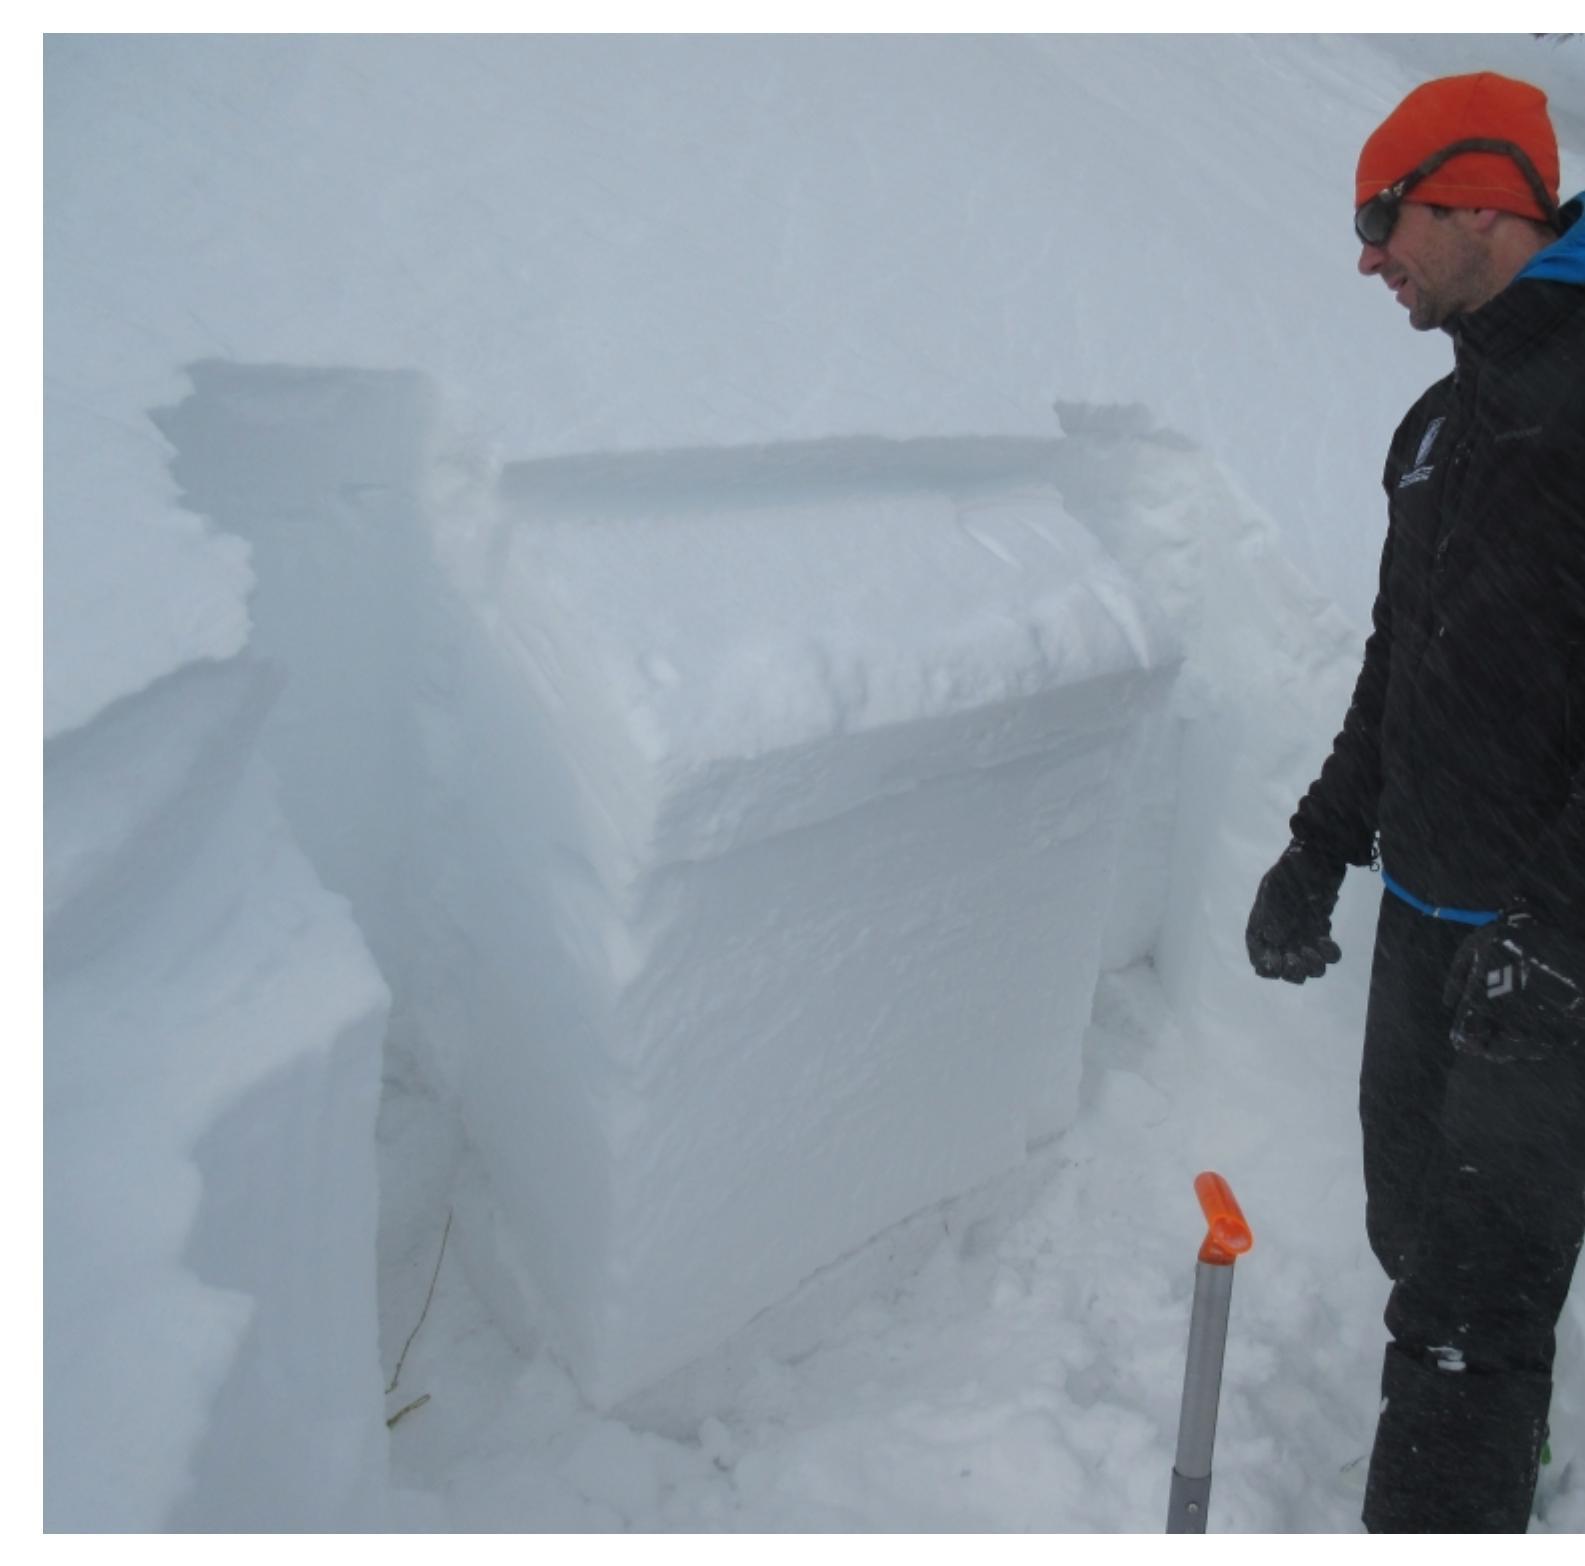
In this pit we had multiple layers propagate in our stability tests. Two wind slabs near the surface, and a thin layer of facets above the hard crust on the ground. ESE aspect at 9,000' near Fairy Lake. Photo: GNFAC
