Advisory Region Northern Gallatin **Avalanche Details:** <u>Road Cut Collapse in Hyalite</u> **Forecast link:** <u>GNFAC Avalanche Forecast for Sun Jan 6, 2019</u> Northern Gallatin, 2019-01-06

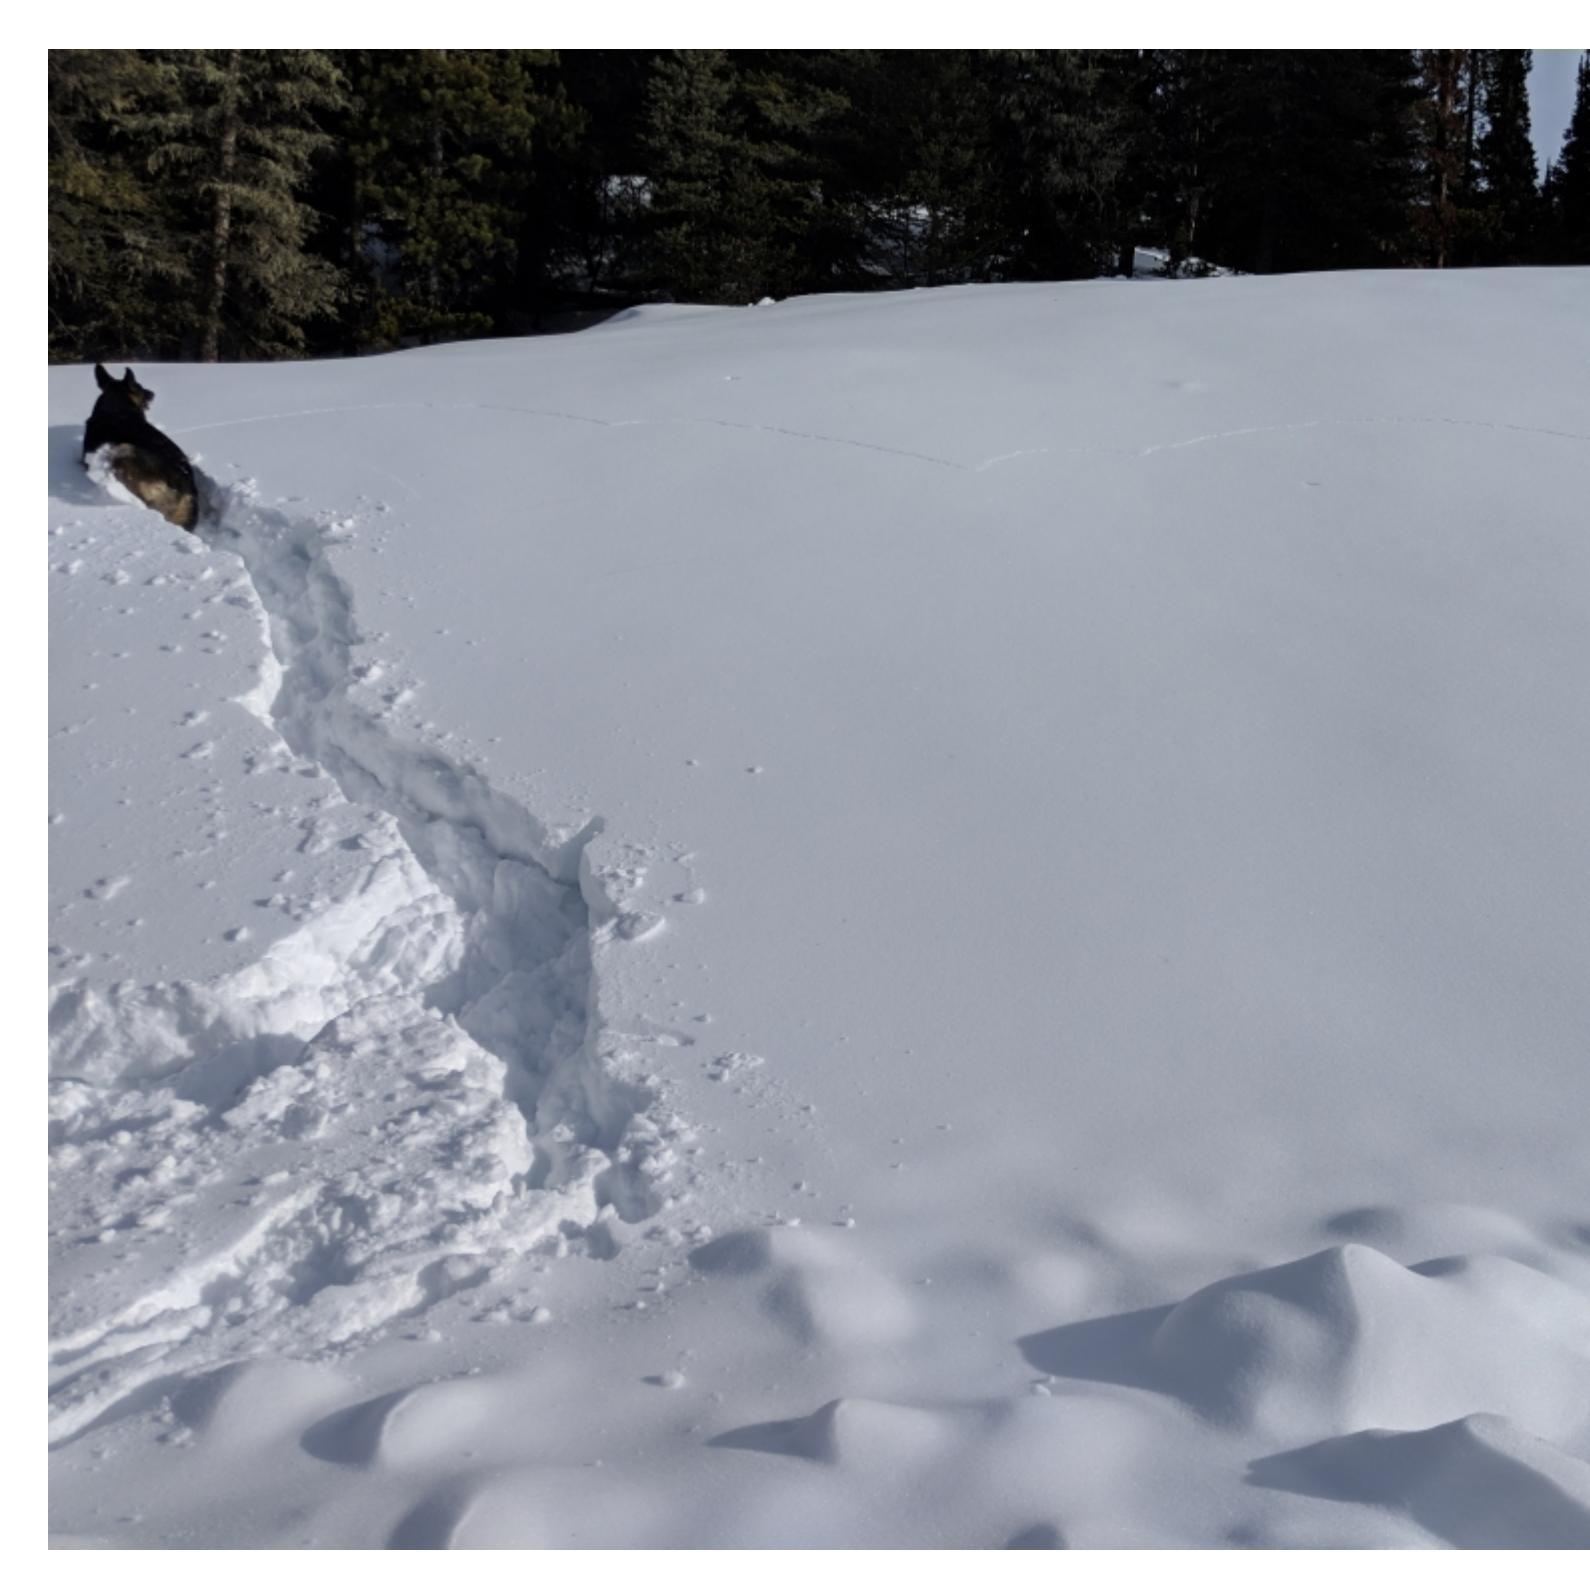
From e-mail: "Witnessed this road cut collapse in hyalite today, by the Palisades parking lot. Easily a foot of dense snow on 12-18" of sugar. Audible collapse as my dog climbed the embankment." C. Bieniek
